Northern Wood Preservers Site Sediment Remediation: EA Follow-up Program

Rob Dobos and Roger Santiago
Environment Canada –Ontario Region

Northern Wood Preservers Site Sediment Remediation

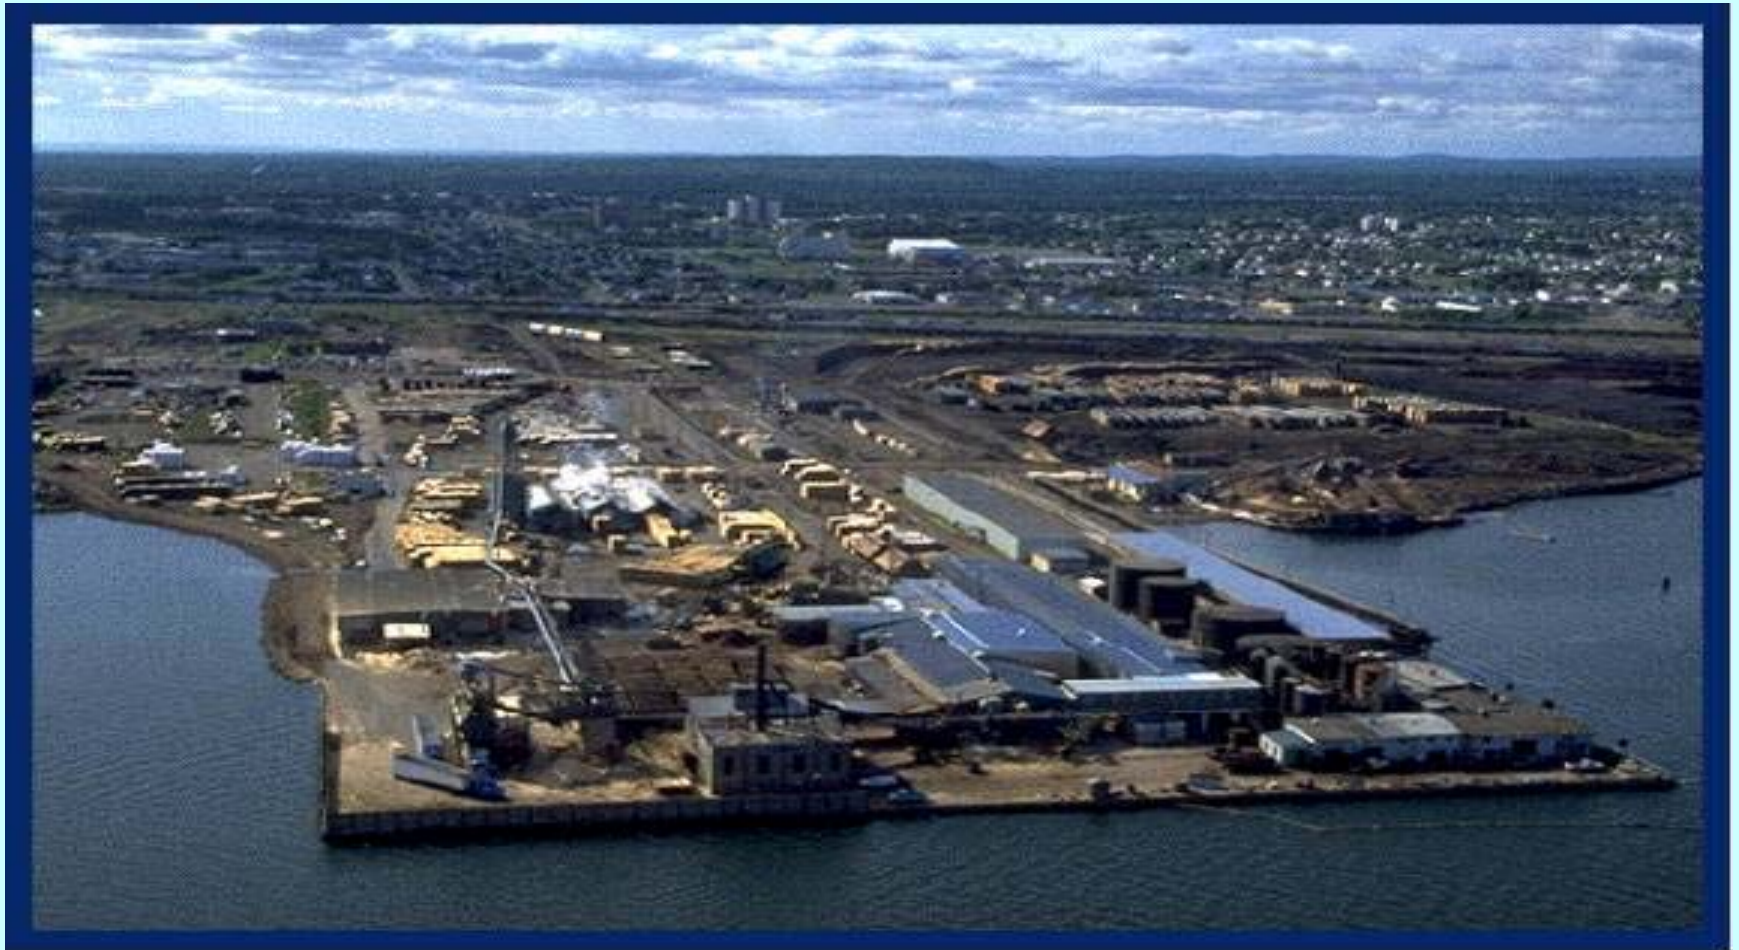
Northern Wood Preservers Site Plan

- Site studied since the late 1970s
- Pools of creosote identified around NWP's property
- Average total PAHs concentration near 10,000 ppm with peaks over 50,000 ppm
- Volume of sediment causing acute lethality to benthos 11,000 m³
- Cleanup criteria established at 260 ppm total PAHs (CCME industrial fill quality criteria)
- Goal: Re-use of treated sediment to create new industrial land

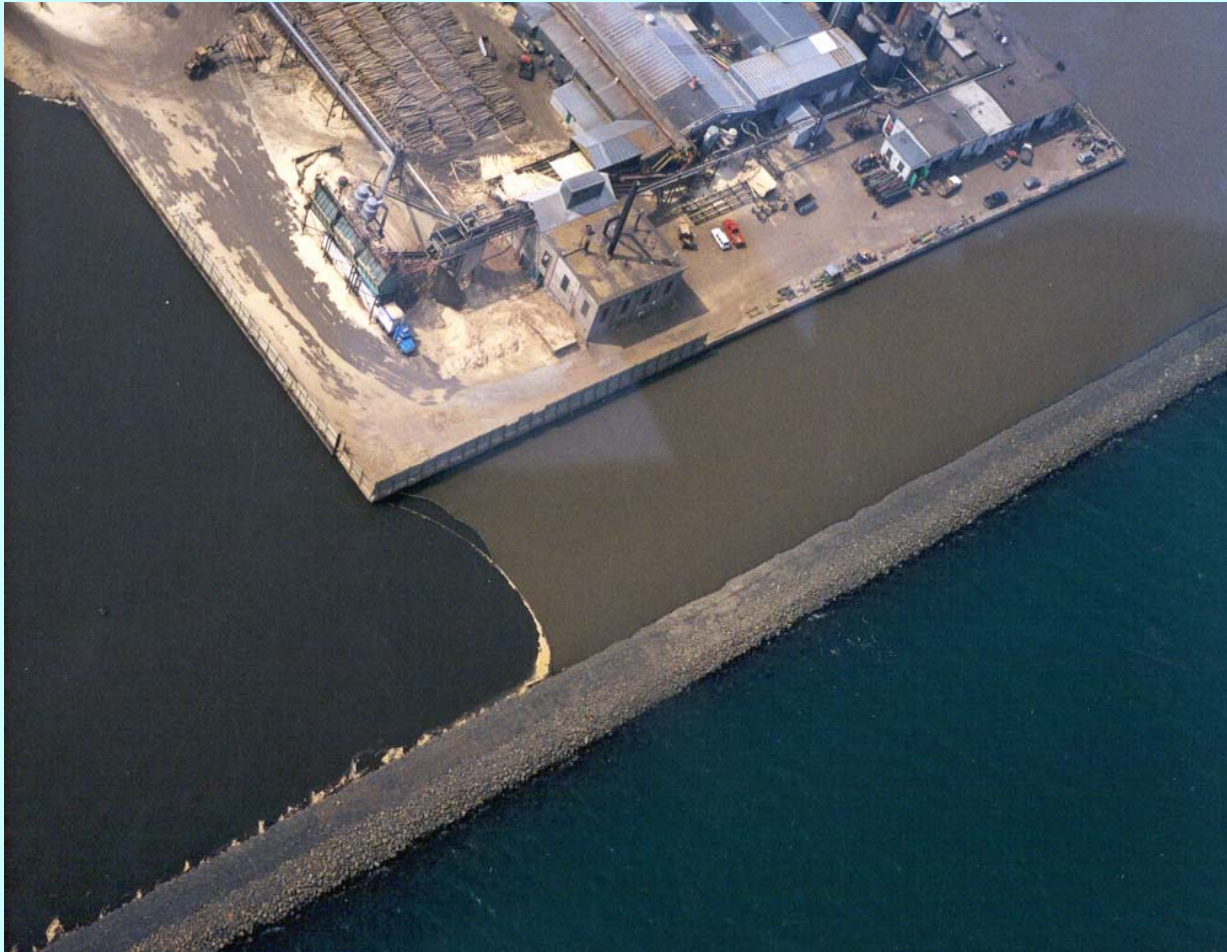
NWP Site Berm Construction Silt Curtain

- Monitoring water quality during berm construction, site isolation, filling and sediment removal

Result: no adverse effects observed

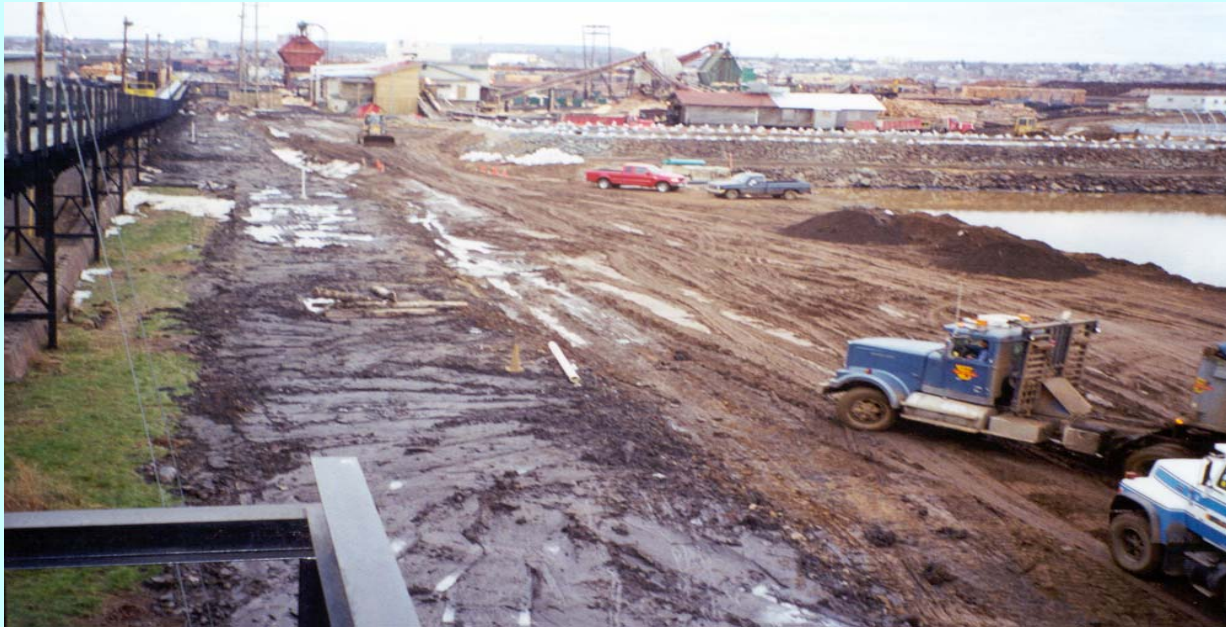
NWP Site Clay Isolation Barrier

- Isolation of source with an environmental clay barrier
- Clean fill placed between clay barrier and rockfill berm
- Over 114,000 tonnes of clay placed over 600m at a cost of \$500,000 CND

Result: clay liner not creating complete seal

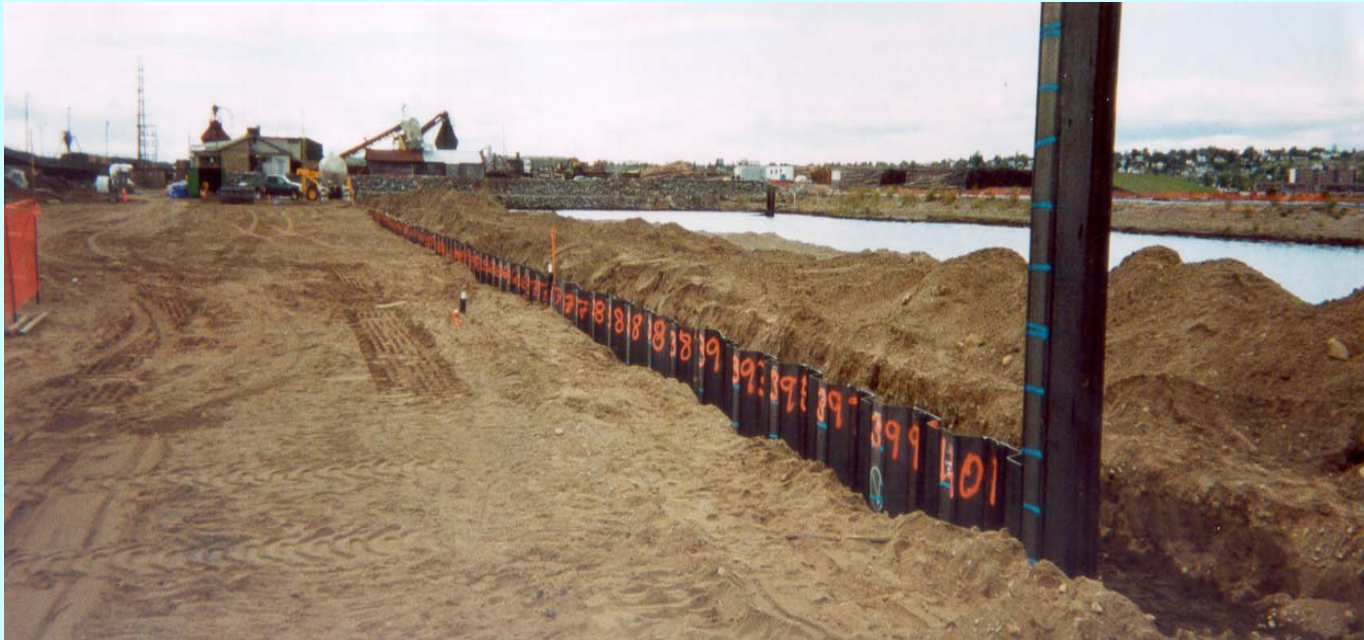
NWP Site - Waterloo Sheet Pile Wall

- Approximately 6000 m² of sheet pile placed along 560 m at a total cost of \$1.9 M CND
- Wells installed throughout filled area for long term monitoring of ground water and removal of creosote

- contingency measure using Waterloo steel pile wall installed
- Pizometers installed throughout fill area for ground water quality and flow

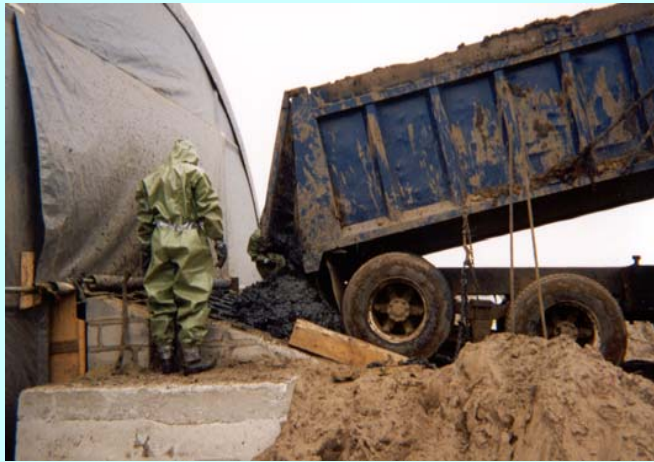
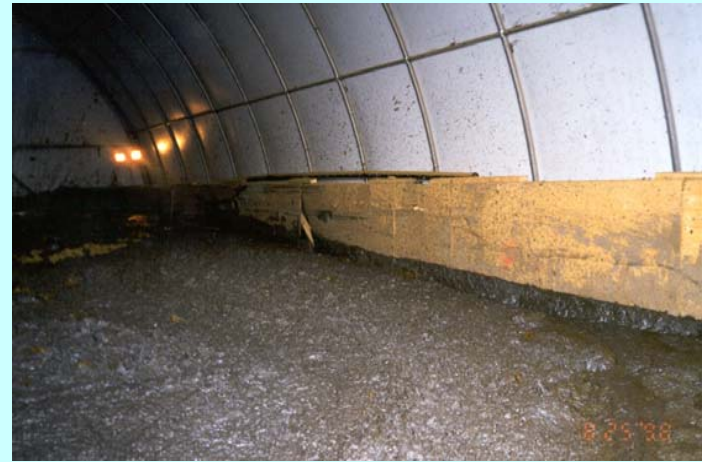
Bioremediation of Contaminated Sediment

- Following dewatering, sediment is dumped into mixing shed through a 6 inch screen
- Daramend™ (nutrient source) is added and tilled into sediment

Result: bioremediation process not meeting cleanup criteria due to higher than expected contaminant concentrations

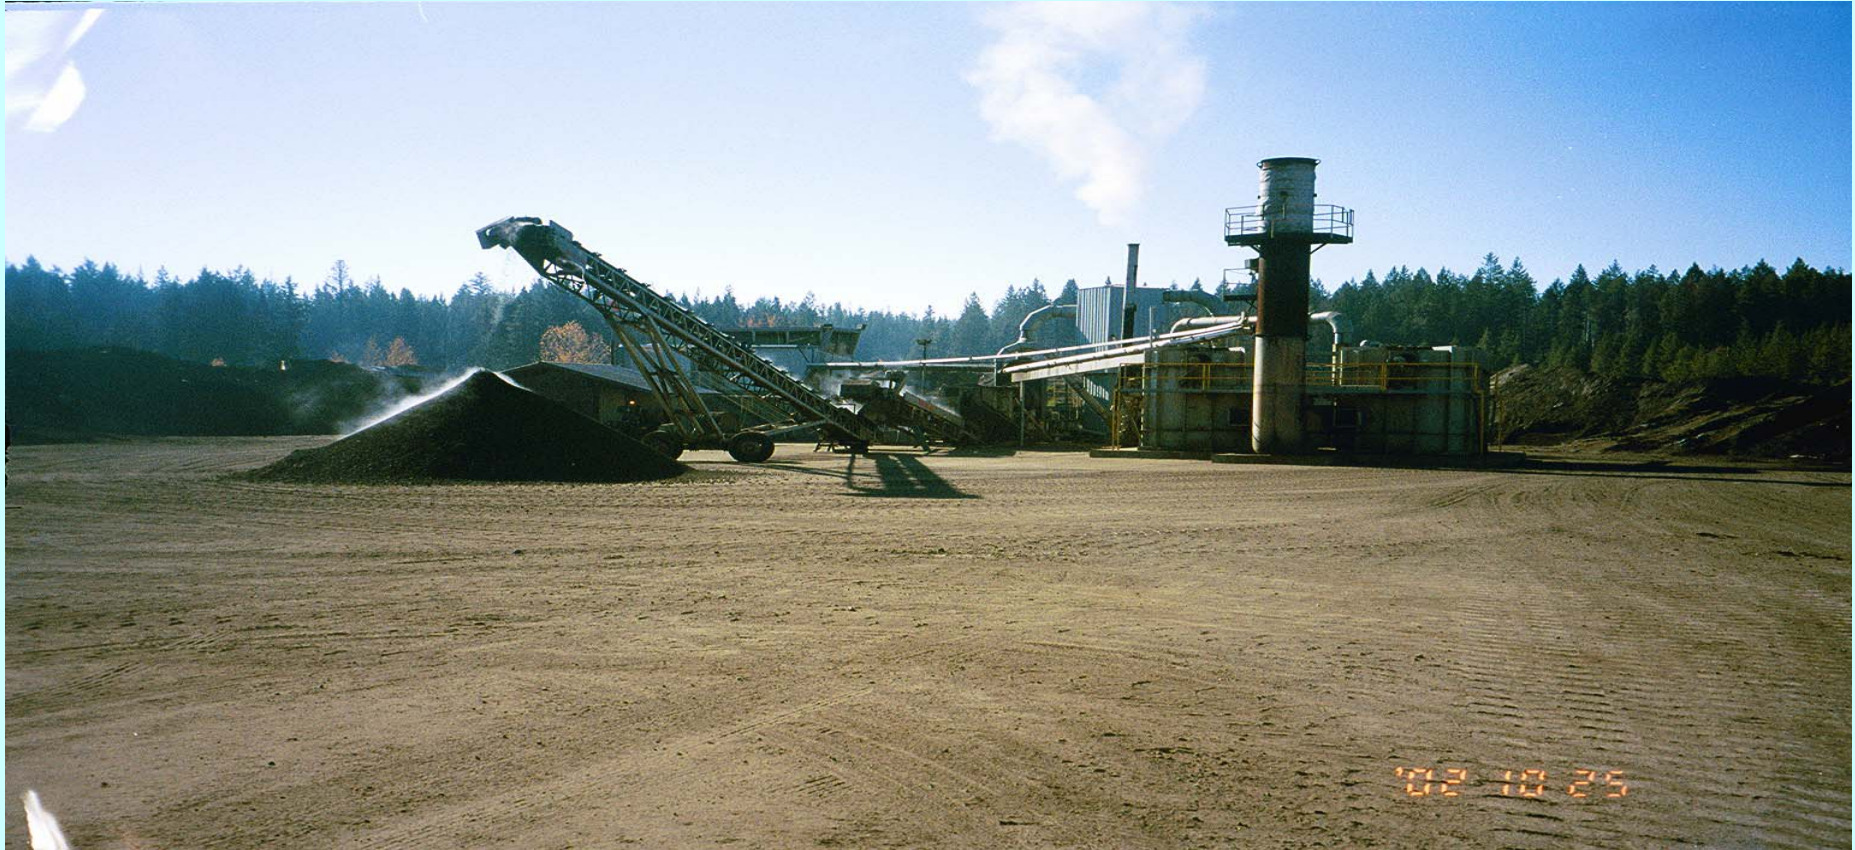
Thermal Desorption Treatment

- Sediment shipped by rail in sealed railcars to Princeton, British Columbia for thermal treatment

- Off-site high temp thermal desorption treatment process implemented –treatment successful

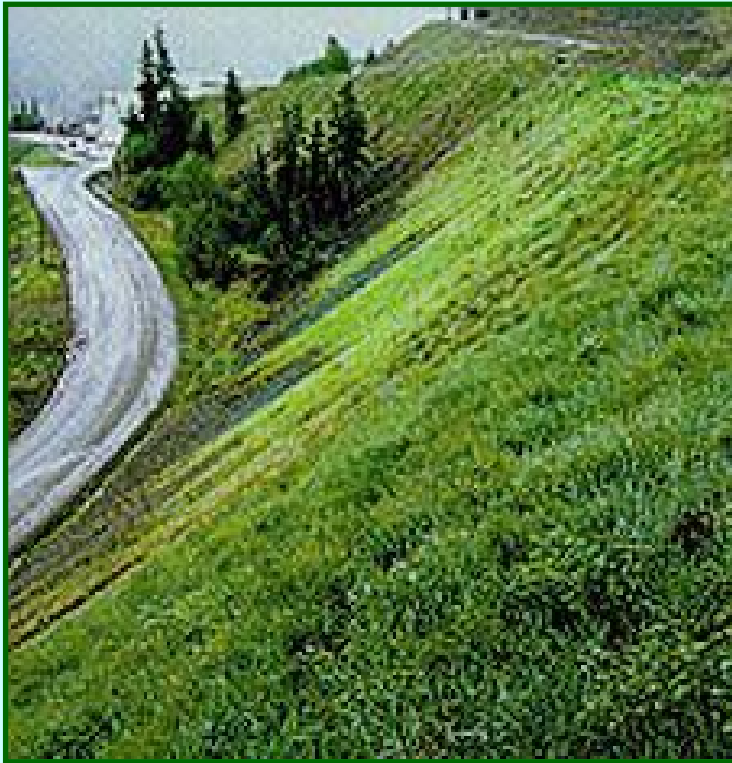
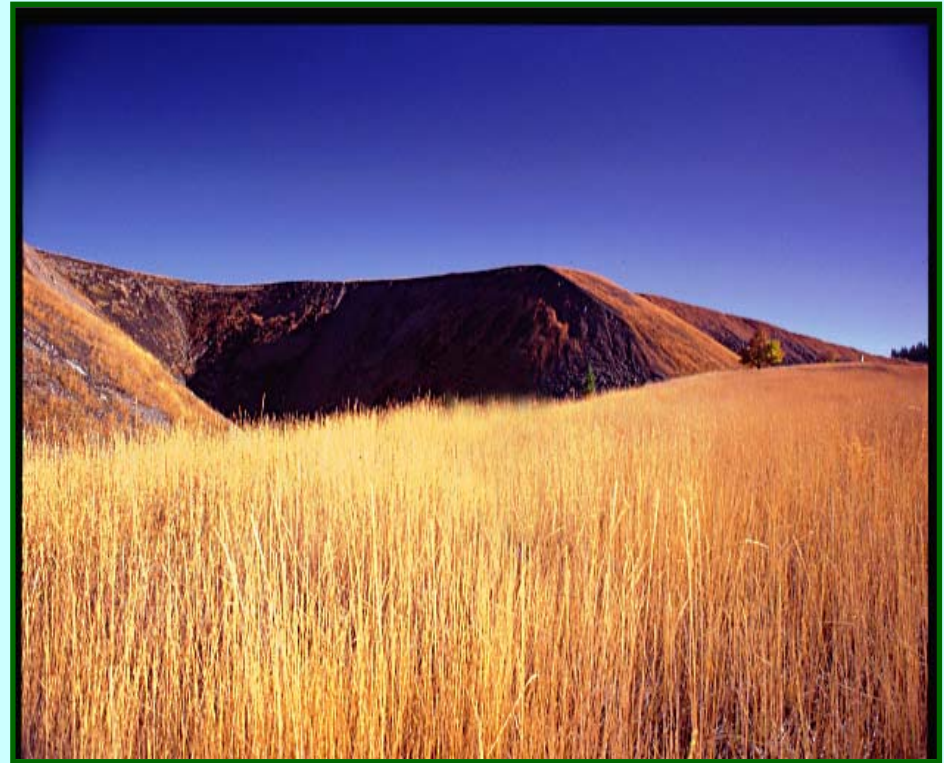
Treated Sediment Reuse in Mine Reclamation

- Sediment treated by thermal process is being used as cover material at a mine site reclamation project outside Vancouver

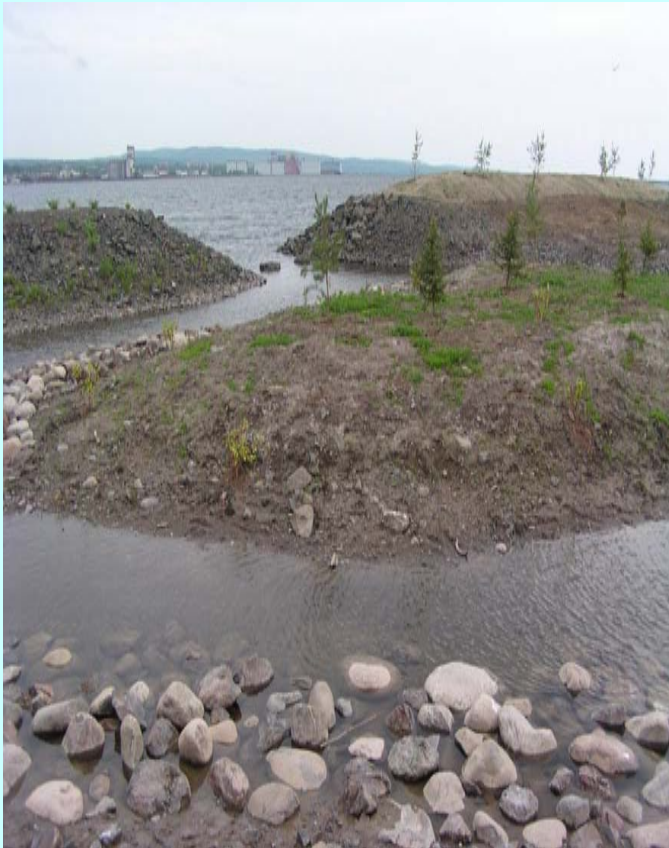
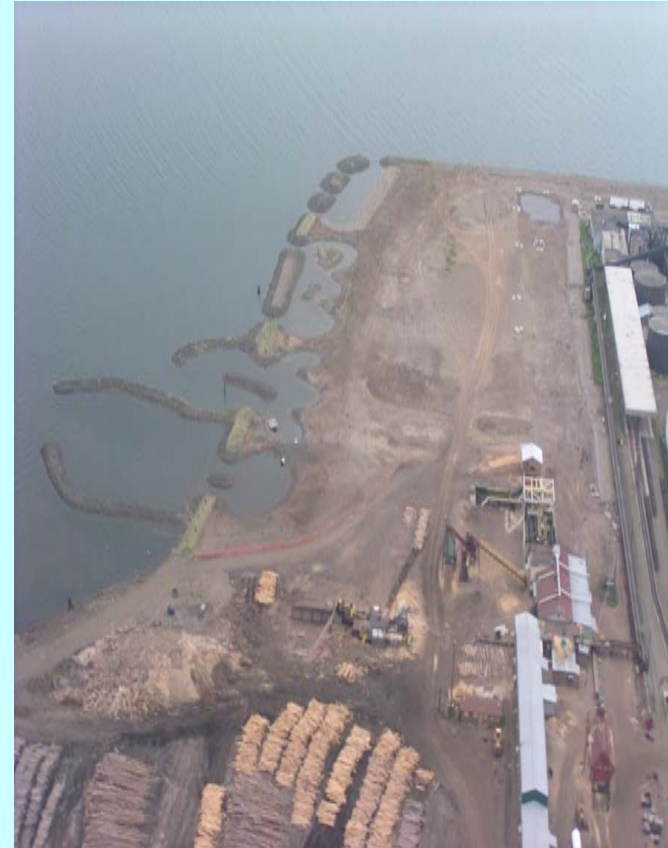
NWP Site Aquatic Habitat Creation

Result: aquatic habitat creation recently completed and monitoring protocol just developed –to be implemented over 10 years

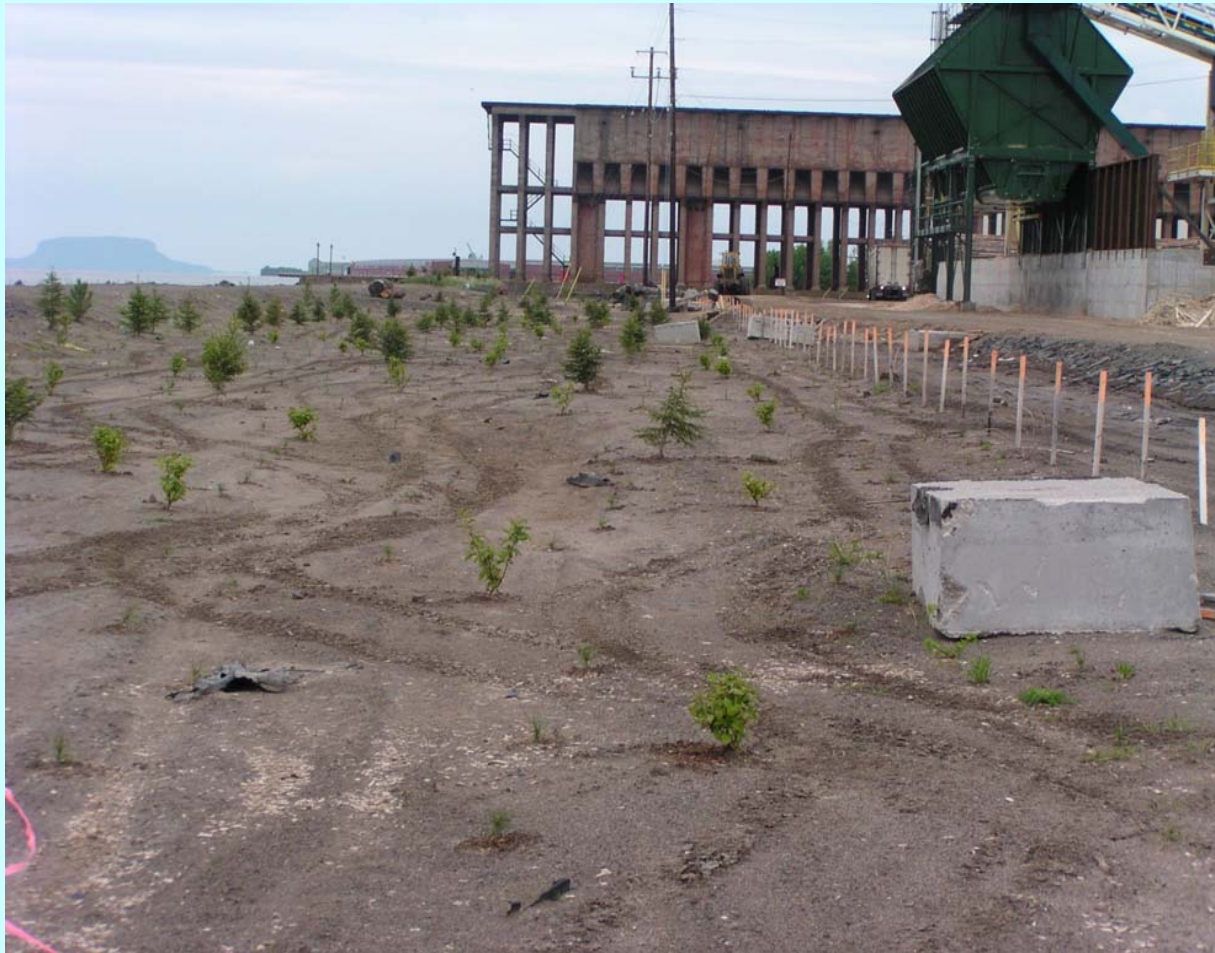
Terrestrial Habitat Creation

Result: no impacts on wildlife observed during construction; 30 m wide buffer of native trees planted along shoreline –monitoring for successful take of trees

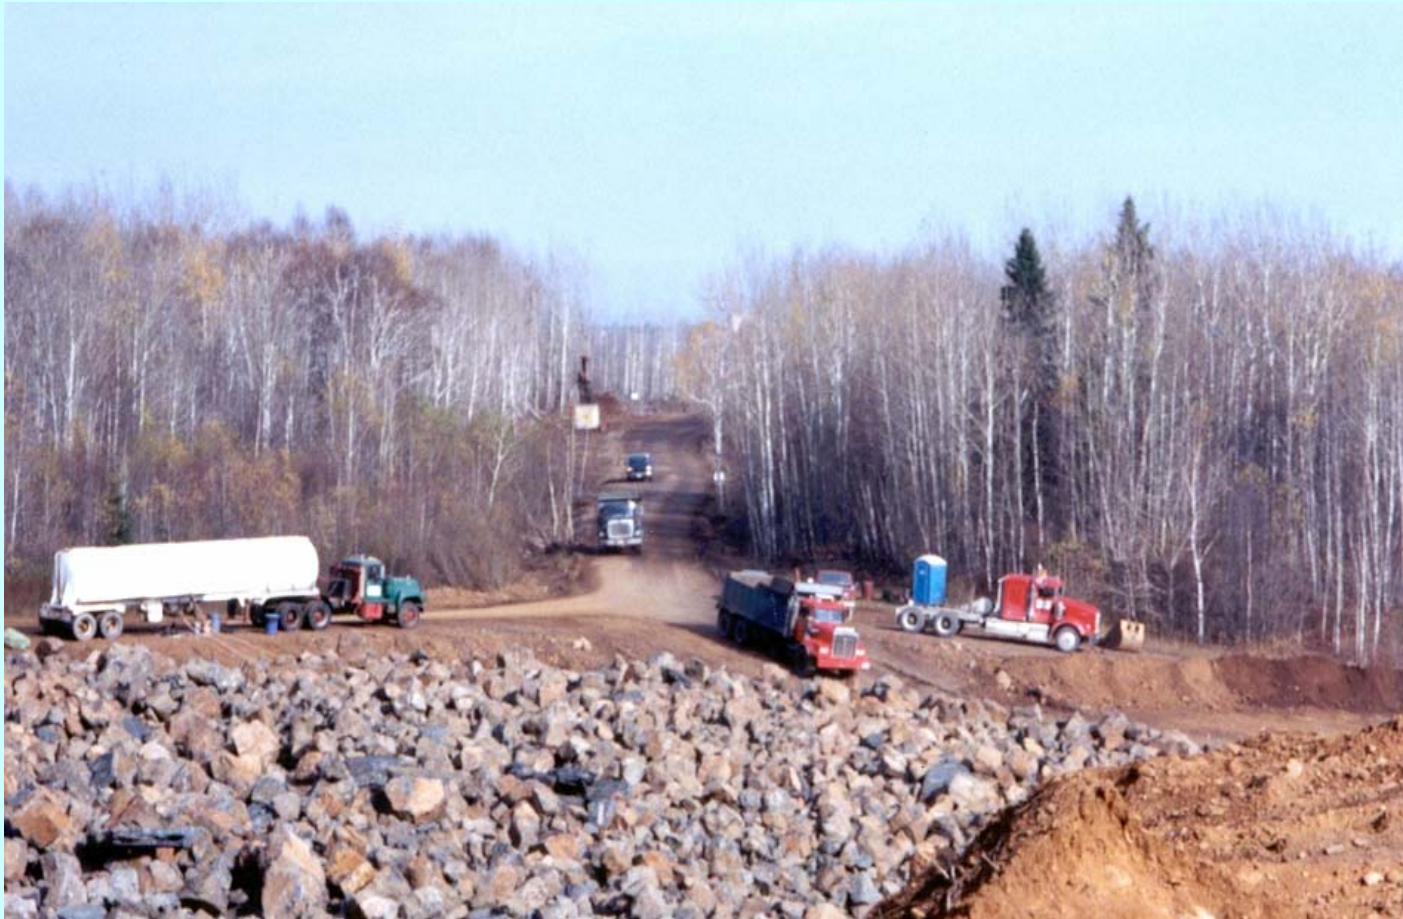
Local Quarry for Rock Fill

- site activities had to accommodate NWP operations
- noise complaints at quarry site for rock fill

- Quarry access road relocated to avoid neighbouring houses

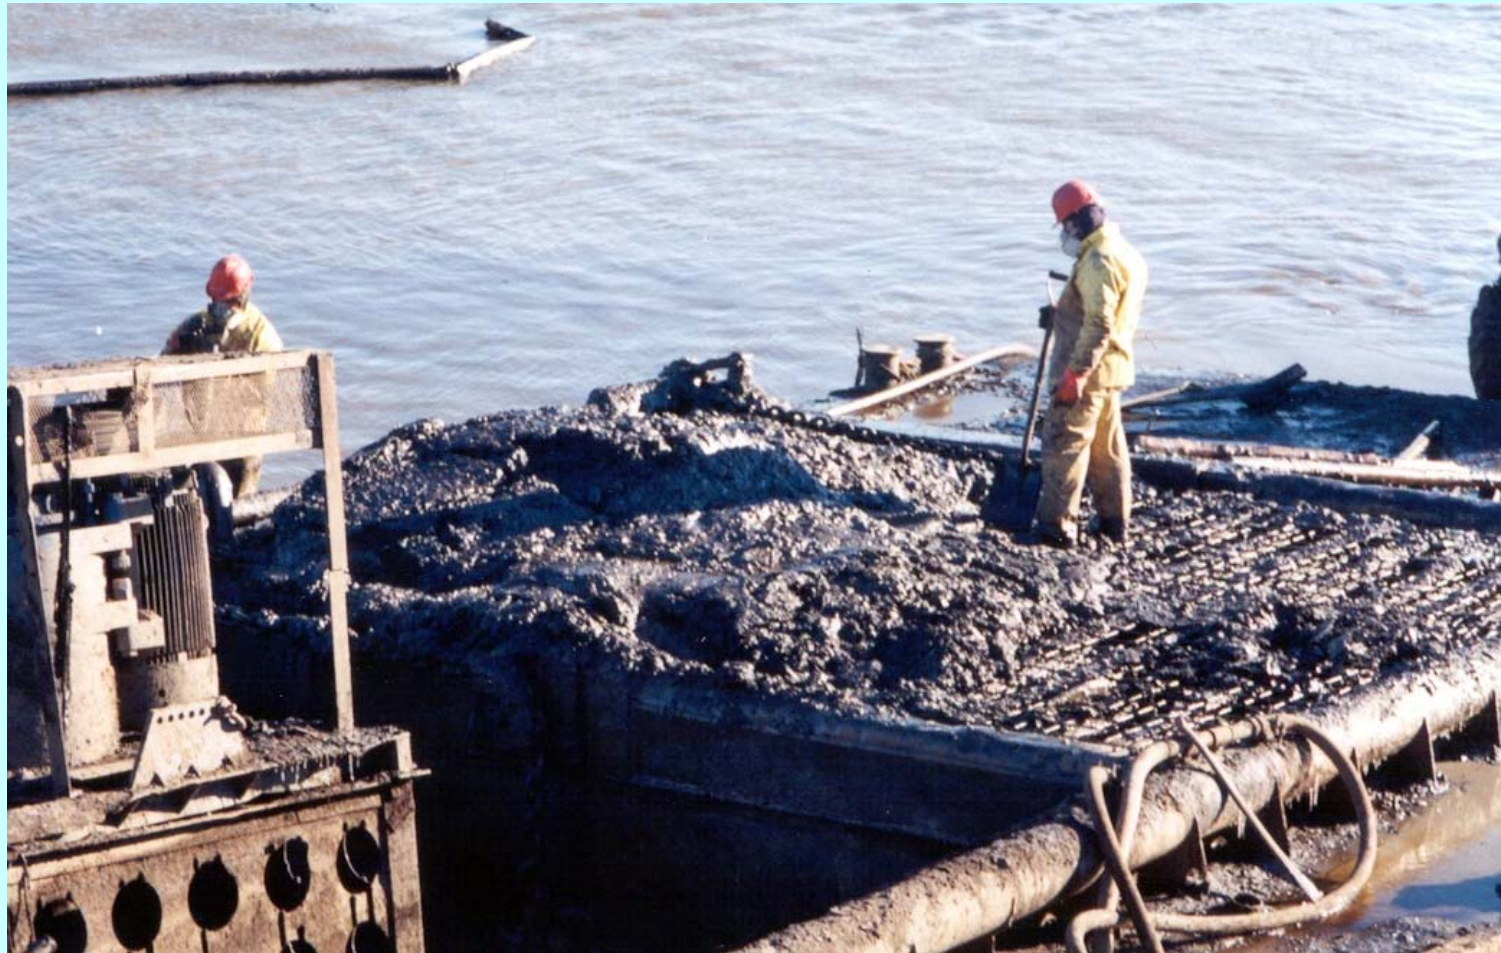
Worker Health & Safety During Sediment Removal

- Not wearing proper equipment or using appropriate equipment
- Ministry of Labour called in to enforce situation

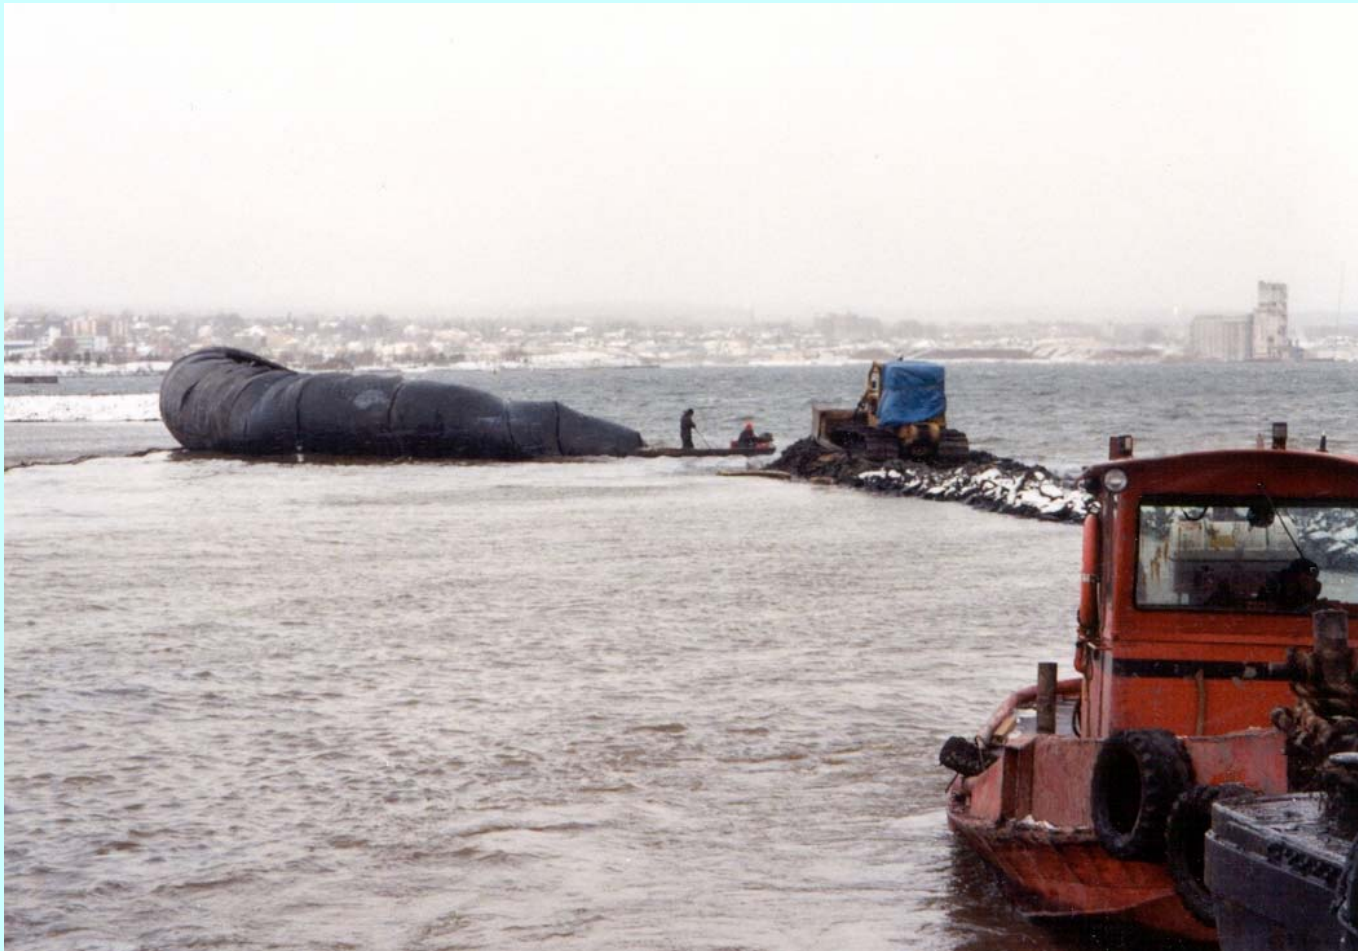
NWP Berm Construction Silt Curtain Failure

Result: a few minor instances –silt curtain failure and blow up; bulldozer slipping into water –effects were minor and localized, situation quickly addressed
