#### **ON THE SUCCESSFUL IMPLEMENTATION OF MITIGATION MEASURES**

*Luis Enrique Sánchez* Escola Politécnica, University of São Paulo

*Amarilis Lucia Casteli Figueiredo Gallardo* Institute of Technological Research, São Paulo

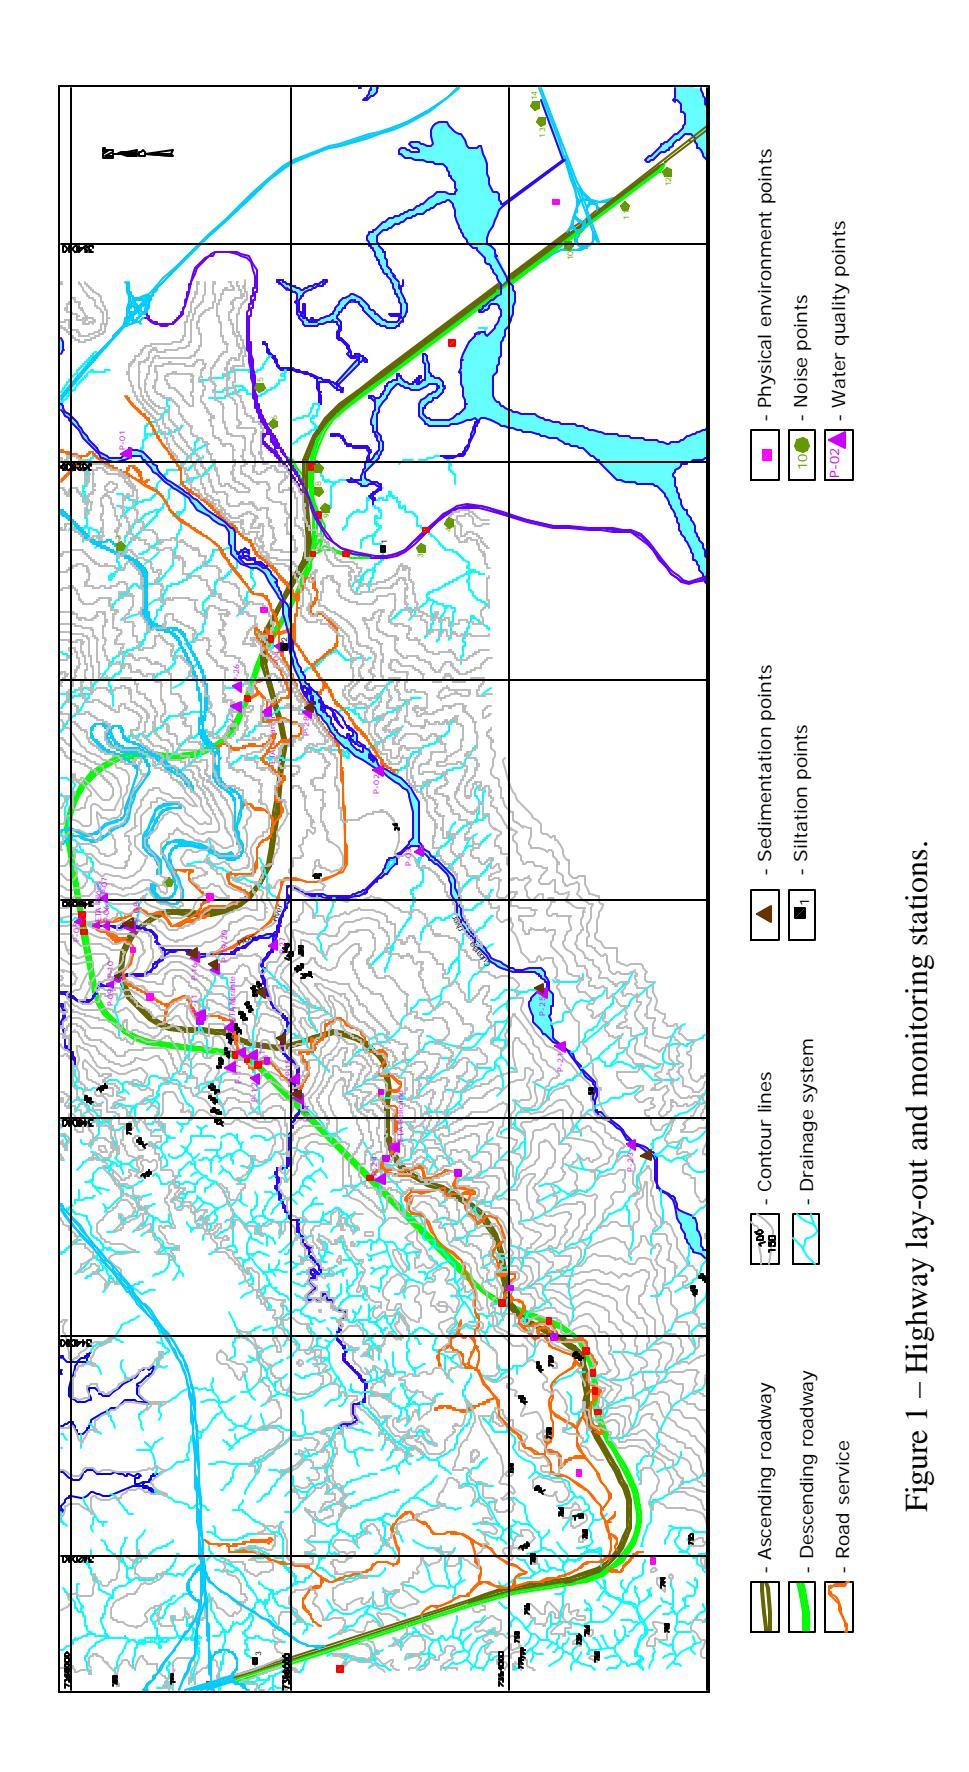
Location of critical inspection points is shown in Figure 1.

Water samples have been collected in 27 control points (Figure 1), 10 upstream and 17 downstream. most of time, however, only 18 points (12 downstream and 6 upstream) have been monitored, due to completion of works in parts of the affected area. The environmental license determined that only pH, water color and turbidity should be measured. Specific water quality limits have been established by the environmental license: limits for pH (6,5 < pH < 7,5) are more stringent than regulatory standards, but limits for color (< 200 mg Pt/L) and turbidity (< 150 NTU) are more permissible than general regulatory standards. This is probably due to the natural dynamics of the *Serra do Mar* environment, featuring high sediment yields after heavy rains.

Noise monitoring was carried out in 14 points (Figure 1) in three campaigns, using standard equipment and methods. All these points are situated in the lowlands, in the vicinity of urban areas and subject to the influence of existing road network. Results were provided in equivalent sound pressure level ( $L_{eq}$ ).

A significant water pollution problem was detected in the initial phases of tunnel excavation. Water draining from tunneling featured high turbidity and suspended solids concentration and reached creeks and rio Cubatão (Figure 1), the major local river. A sudden change in water color has been observed by the downstream local population. This prompted the State pollution control agency (Cetesb, a branch of the Environment Department) to forbid any further discharge. Four wastewater treatment plants have then been built to neutralize alkaline drainage and to precipitate solids. Even so, one creek showed extensive carbonate precipitation over boulders and creek floor and had to be later manually cleaned up.

Sound pressure levels ranged from 54 to 80 dB(A) in the first campaign (June 2001), from 55 to 78 dB(A) in the second campaign (December 2001) and from 55 to 79 dB(A) in the third campaign (June 2002). The worst point is #2, situated right besides an upwards lane of the 1950 road, subject to intense truck passage, whereas point #4, situated beside a flat extent of another road, showed the lower figures (Figure 1).

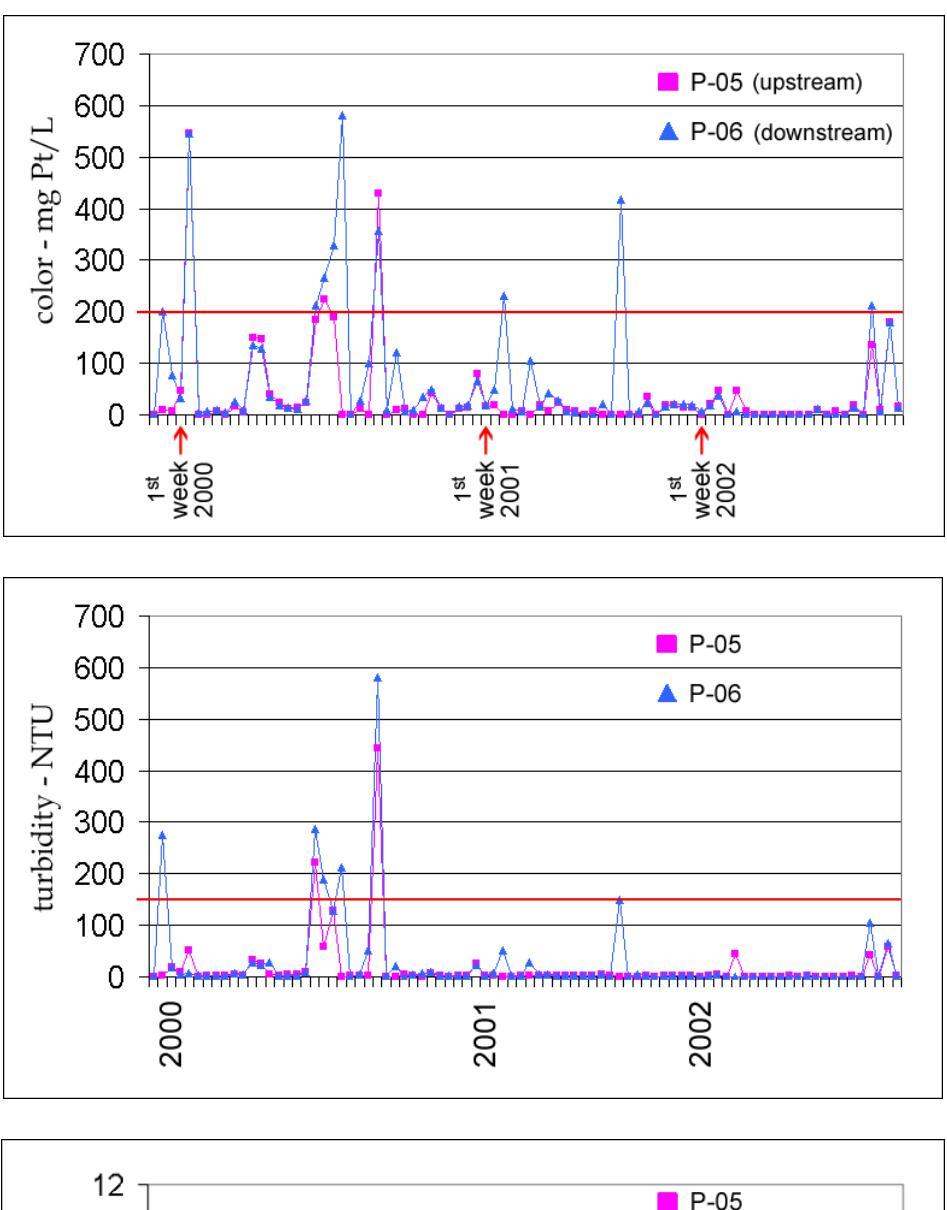
Data for water quality showed that most of time quality standards have been met, except for pH. Out of a total of 1220 samples, 475 (38,9%) exceeded quality standards for pH, 17 (1,39%) exceeded quality standards for turbidity, and 27 (2,21%) exceeded quality standards for water color. An example is provided by results obtained in two points located upstream (P-05) and downstream (P-06) of road works, in the vicinity of water intake to a public supply treatment plant. (Figure 2).
